## §18. Change of Optical Properties of Retro-reflector Installed in LHD

Akiyama, T., Kawahata, K., Tokuzawa, T., Ashikawa, N., Tokitani, M., Okajima, S., Nakayama, K. (Chubu Univ.), Yoshida, N., Tokunaga, K. (Kyushu Univ.)

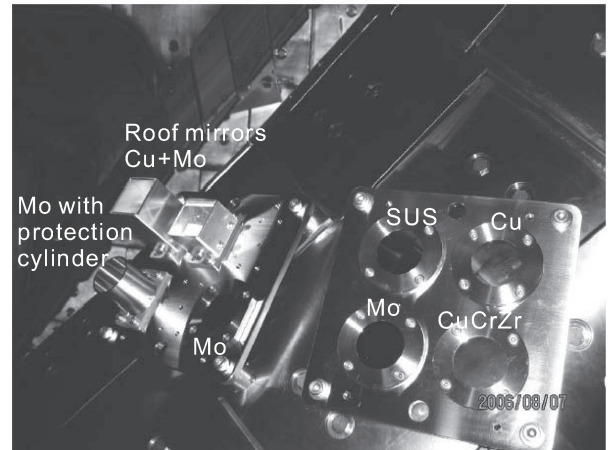
Figure 1 is a photograph of test mirrors installed in LHD. These mirrors are exposed to plasmas during whole 10th experimental campaign. It consists from flat mirrors with different metal (Mo, stainless steel, Cu, CrZrCu) and mirrors with protection cylinders (flat and roof mirrors). Mo mirror with the protection cylinder is to study effects of the cylinder. Roof mirrors are to study how sputtered particles are transported on the mirror surface because it was reported that the deposited particles were accumulated to the central region of a retroreflector [1, 2]. These mirrors are installed on helically wound coils near 8.5UL ports.

Fig.1: A photograph of test mirrors installed in LHD vacuum vessel.

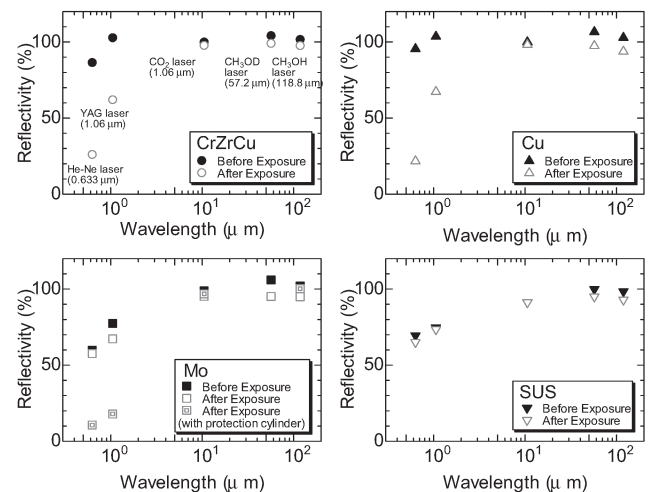
Figure 2 shows the reflectivity of four flat mirrors before and after exposure to plasmas in the wavelength range from visible to far infrared. The reflectivity for longer wavelength than 10  $\mu\text{m}$  does not deteriorate very much regardless of the materials. However, the reflectivities of Cu and CrZrCu mirrors in near infrared and visible region decrease significantly while these of Mo and stainless steel mirrors show just a slight decrease. In order to understand how the reflectivity decrease, the surfaces were observed with SEM and materials on the mirror surfaces were analyzed with EDS. Photograph of the surface of CrZrCu mirror after the exposure is shown in Fig.3. Spherical objects, whose diameters are less than 1  $\mu\text{m}$ , are found on the surface. EDS analyses show that these objects consist from copper not iron or carbon which come from the vacuum vessel wall and divertor plates. Since copper is rarely used in LHD except this mirror, these objects are expected to be formed by gathering sputtered copper. Similar objects are observed on the Cu mirror surface, too. The decreases in the reflectivity of CrZrCu and Cu mirrors seem to attribute to surface roughness due to these spherical objects and depressions. On the other hand, surfaces of stainless steel and Mo mirrors are still smooth even after the exposure to plasmas. This is due to low sputtering yields.

There were impurity depositions, which causes significant degradation in the reflectivity as shown in Fig. 2, on the Mo mirror with the protective cylinder while no deposition on the flat Mo mirror without the cylinder. These depositions are expected to come from the vacuum vessel or the cylinder. Though the cylinder is effective to reduce direct bombardment by charge exchange particles, it

Fig.2: Reflectivity of flat mirrors (CrZrCu, Cu, Mo and stainless steel) before and after exposure to LHD plasma

also plays a role as a source of deposition particles. Hence the studies of shapes of the cylinder to prohibit impurities from falling on the mirror surface are going now.

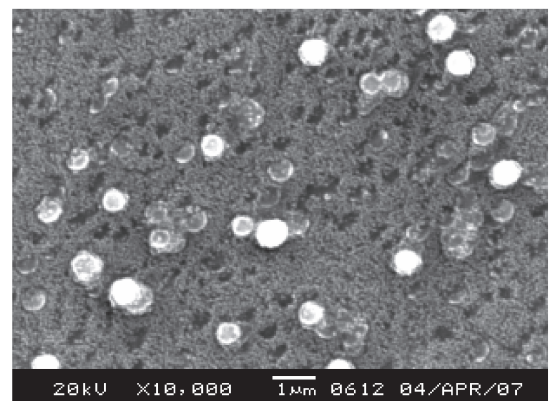
Fig.3: Surface of CrZrCu mirror after exposure to LHD plasma
