# Reflectivity Reduction of Retro-Reflector Installed in LHD due to Plasma Surface Interaction

**Abstract:** Optical reflectivity of the retro-reflector installed in LHD as the first mirror was reduced seriously by plasma wall interaction. In order to understand the mechanism of the reflectivity reduction, optical and material properties of the mirror surfaces have been examined extensively. It was found that the deposited impurity layers caused the serious reduction of the reflectivity. Formation of iron oxide, bulges structure and He bubbles are the major factors for the reflectivity reduction in the wide wave length range.

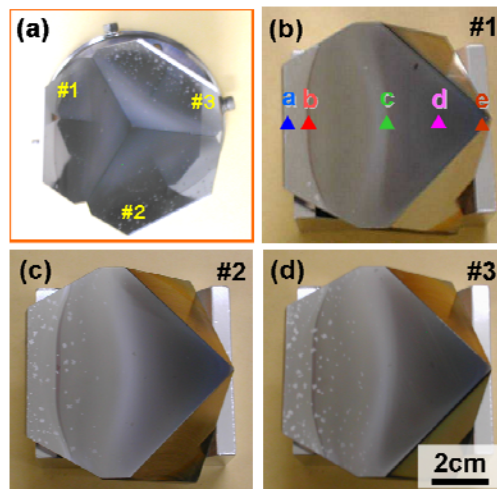
Photographs of the retro-reflector and its three flat mirrors are shown in Fig.2. As can be seen, strong blacking, namely reduction of optical reflectivity, occurred especially at the cubic corner where three mirrors contacted each other (corner at right-hand side in the photographs). Inspections were carried out mainly for the #1 mirror.

Fig.2 Photographs of a retro-reflector looking from the laser incident direction (a), and its three flat reflectors (b)-(d). Reflectivity and corresponding surface morphologies are mainly examined at the points **a**, **b**, **c**, **d** and **e** of the #1 flat mirror.

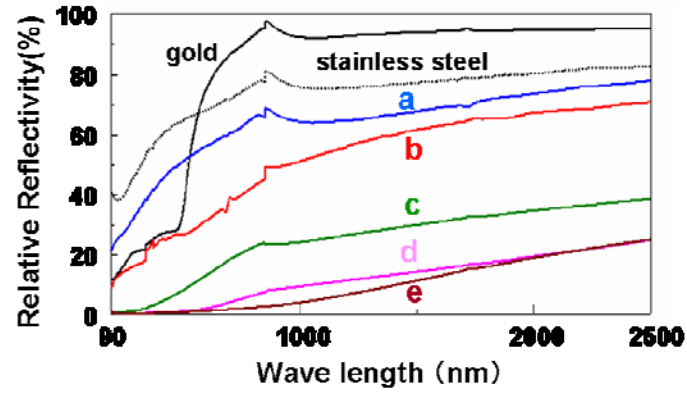
Figs. 3 and 4 show optical reflectivity measured at the five points **a**, **b**, **c**, **d** and **e** from the aperture edge to the cubic corner of the reflector as denoted on the photo in Fig. 2 (b). Discrete data at 900nm in Fig.3 was caused by changing the detectors at this wave length. Reflectivity of a stainless steel mirror and a gold mirror are also plotted in the figure for comparison. The area near the aperture edge had lost the original gold color but shows a typical gloss of metals. As can be seen in Fig. 3, reflectivity spectrum at the point **a** is quite similar to that of stainless steel. Point **b** corresponds to the narrow arc region having brown color. In contrast, the reflectivity at the points **c**, **d** and **e** decrease drastically by approaching to the cubic corner where the laser beam reflected. The reflectivity for short wave length below visible region is almost 0%. It is worth to note that the reduction of reflectivity at infrared region is also remarkable; for example, reflectivity reduction for CO<sub>2</sub> laser (wave length=10.6μm) at the points **d** and **e** is 50-60%. In case of retro-reflectors the substantial reflectivity is less than 20%, because reflection occurs three times.

Fig.3 Reflectivity at the points *a*, *b*, *c*, *d*, and *e* for the wave length between 90nm and 2500nm. Those for gold and stainless steel are also plotted in the figure.

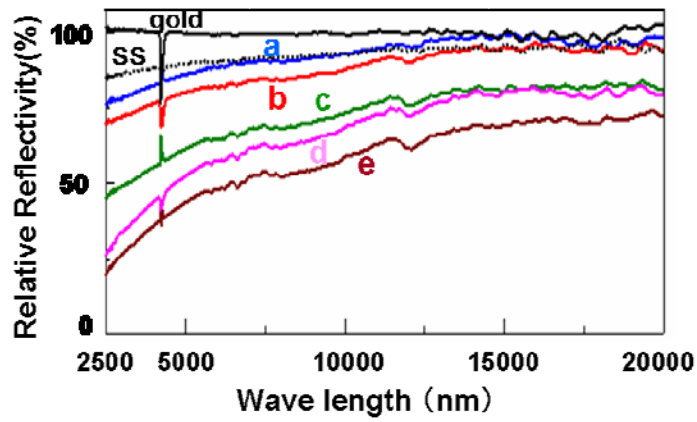
Fig. 4 Reflectivity at the points *a*, *b*, *c*, *d*, and *e* for the wave length between 2500nm and 20000nm. Those for gold and stainless steel are also plotted.

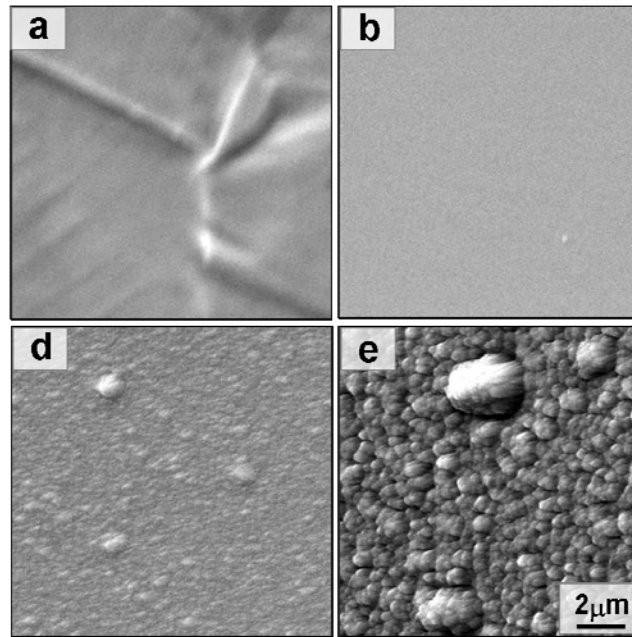
Fig. 5 SEM micrographs showing surface morphology at points *a*, *b*, *d* and *e*.

Beyond the point **b** metallic gloss diminished gradually and the color of the surface turned to black. As shown in the SEM micrographs in Fig.5 (d) and Fig.5 (e), the surface is covered by fine sub-micron hills of about 200-800nm in diameter. In addition projections larger than 1 $\mu$ m in diameter exist in places. Height of the sub-micron hills and the large projections increases by approaching to the cubic corner.

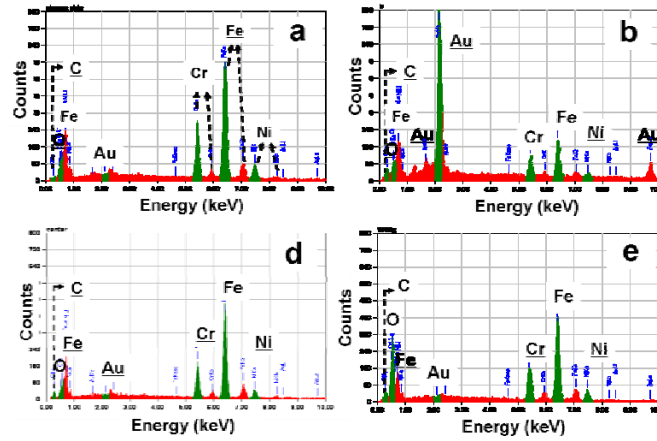
Fig. 6 EDS spectrum showing chemical composition at the points **a**, **b**, **d** and **e**.

EDS analysis shown in Fig.6 indicated that the major elements at the points **d** and **e** are Fe, Cr, Ni and O. Content of O is very large at the point **e**. These results indicate that majority of the deposited impurities came from the plasma. Fig. 8 is a SEM image where the deposition detached at the interface between the gold (point **e**). Thickness of the deposition is about 2 $\mu$ m.

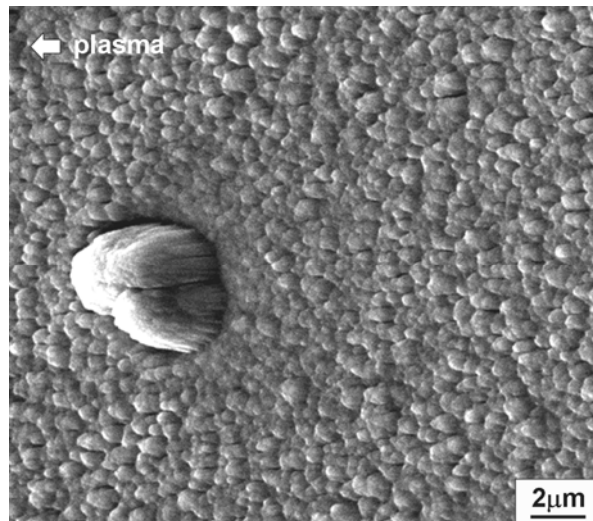
Fig.7 is a magnified SEM micrograph showing details of the surface morphology. It is interesting that the sub-micron hills and the projections incline somewhat toward the left-hand side in the micrograph, namely toward the aperture of the retro-reflector. Development of the sub-micron hills in the left hand area of the large projection is delayed. The height of the sub-micron hills was estimated to be 100-500nm from the stereoscopic observation. Height of the large projection exceeds 2.5 $\mu$ m.

Fig. 7 Formation of sub-micron hills around a large projection, SEM micrographs at the point **e**.

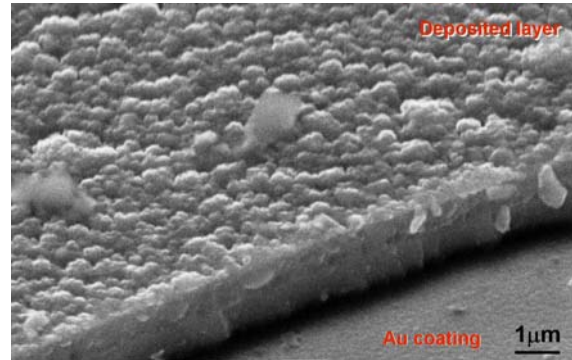
Fig. 8 SEM micrograph showing exfoliation of the deposited layer: Original Au-coated surface appeared after the exfoliation (lower right part).

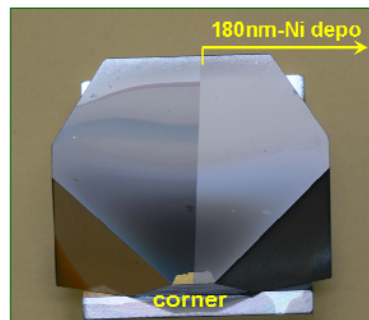
In order to clarify the mechanism of reflectivity degradation, 180nm-thick nickel layer was deposited in vacuum on the surface of the mirror. This thickness is high enough to hide the optical properties of the original surface and change them to those of Ni, but thin enough to keep the surface morphology with sub-micron scale roughening. As can be seen in the photo of the mirror after Ni deposition in Fig.9., influence of the original surface had gone and showed typical color of Ni in the area of the points **a** and **b** where the surface is rather smooth. In contrast, at the heavily blacken area (points **d** and **e**), the Ni deposition hardly changed the color. These results indicate that the major reason of the blacken near the cubic corner is the surface roughening by the formation of sub-micron-scale hills.

Fig. 9 Photograph of the reflector whose right-half was covered by a vacuum deposited Ni thin film of about 180nm thick.

The result of Ni deposition effects shown in Fig. 9 strongly indicates that the serious reduction of the reflectivity at the visible wave length region can be explained by the formation of the dense hills of about 200-300nm-high. It is well known that the relative reflectivity of the uneven surface is given by the following equation [12].

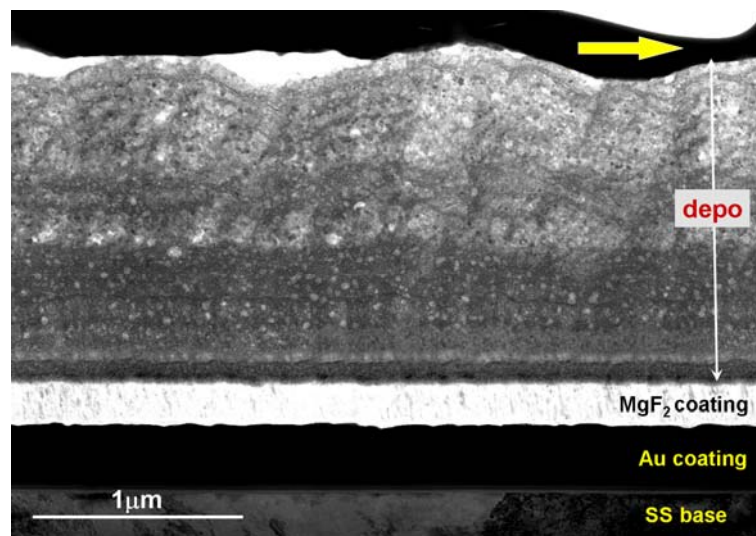
In order to understand the mechanism of the reflectivity reduction, cross-sectional structure and its chemical composition of the deposition were examined microscopically by using TEM and STEM with EDS. The thin cross sectional samples of about 200nm-thick were prepared by means of FIB technique from the area **e** shown in Fig. 2. Fig. 10 is cross-sectional TEM image of the deposition formed on the original mirror surface coated by MgF<sub>2</sub>. It is remarkable that the deposition has clear layer structure. Up to about 0.67μm for the original mirror surface the layer was rather flat and has dark contrast. Above 0.67μm the layers become wavy suddenly and the wave inclines toward the main plasma direction just as expected from the SEM image shown in Fig. 7. The final thickness of the deposition is about 1.6μm in this case. The image of lower flat part is uniformly dark, while that of the upper wavy part is rather light. This result indicates that the average density of the former is high but that of the latter is low. EDS analysis

Fig.10 Cross-sectional TEM image of the deposition at the point *e*.

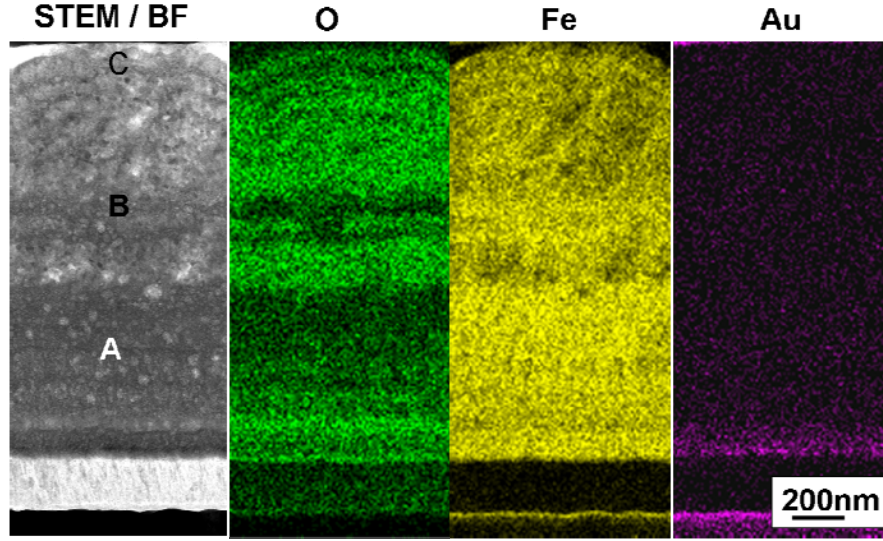
indicates that Fe, Cr, Ni, Au and O are the major elements composing the deposition. Fig. 11 shows two dimensional distributions of deposited elements, O, Fe and Au together with the corresponding STEM image. The distribution of Cr and Ni are similar to that of Fe.

At the beginning of the experimental cycle long He glow discharge cleaning were performed previous to the main discharge experiments. As shown in Fig. 11, EDS data indicate that Au from the mirror itself, probably from the point **a** area shown in Fig. 2 where strong erosion occurred and the plated gold has gone, was deposited together with Fe and O form the protection wall made of stainless steel. Content of Au quickly decreased.

Fig.11 Two-dimensional distribution of O, Fe and Au in the deposition at the point e.

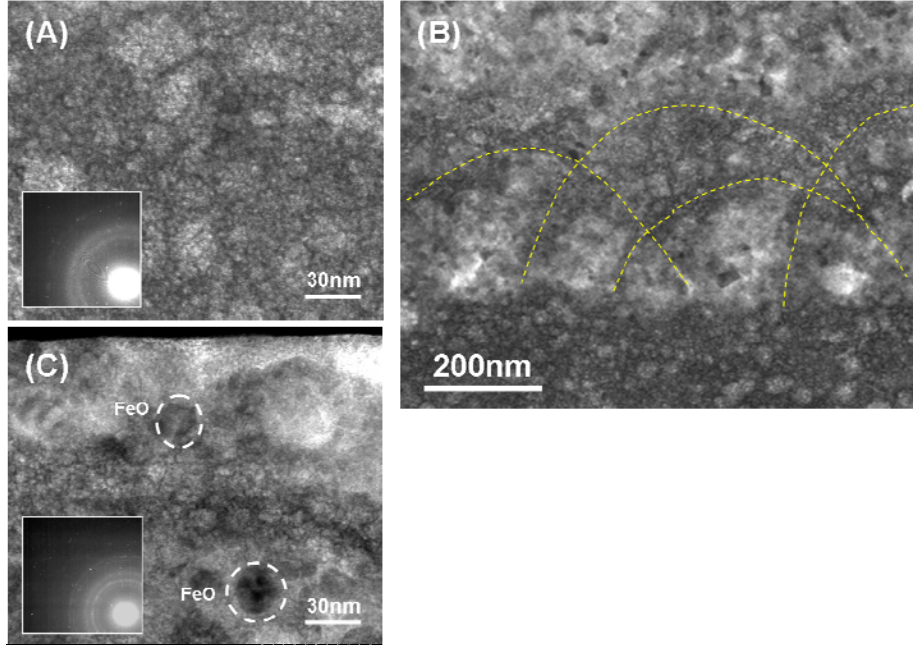
Characters of the deposition changed clearly at the hight of about 100nm. Above this level the content of O increased discontinuously and then gradually decreased up to 670nm by reaping fluctuation. A typical microstructure of this area (point A in the figure) is shown in Fig.12 (a). The deposition is composed of very fine crystals. The electron diffraction pattern (EDP) indicates that most of them are FeO crystals. It is remarkable that the nano-scale bubbles having white dot image were formed densely together with large bubbles of about 10-40nm in size. It is likely that high pressure gas of He and H exist in these bubbles.

The looking of the deposition drastically change above 670nm. Fig.12(b) is the magnified micrograph at the interface and EDP from the upper region. Just above the interface the deposition is hollow (large white region in the micrograph). Content of O is very high and large FeO crystals of about 10-30nm in diameter are formed. The most prominent feature is the deposition is not flat but very complicate. The dotted lines in the figure trace the layer with dark image of about 100nm-thick. It is clear that the layers have half-circle shape of about 500-600nm in diameter extending from the interface. It is also important that below the half-circle dense layer, there is a large hole. Taking into account that the thickness of the sample is about 100nm, these images indicates that they are blisters with shape of half-sphere domes of about 300nm-high. They are densely formed at the interface. The material of the blisters is mainly fine FeO crystals and dense nano-scale bubbles are formed in it. After the formation of the blisters surface of the deposition becomes wavy and wavy with increasing the thickness of the deposition.

A magnified micrograph and EDP near the top surface (point C in Fig. 11) is shown in Fig.12(c). It is clear that layers with lower density (light contrast) and those with higher density (dark contrast) were formed one after another.

Fig 12 Magnified TEM micrographs at A, B and C.

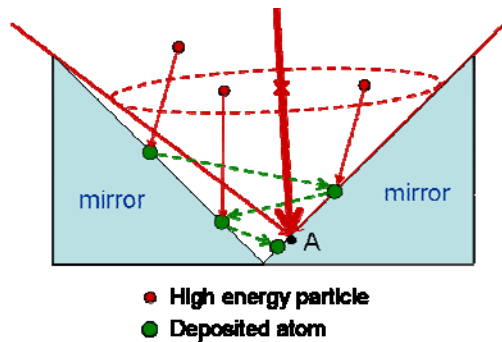
The area near the cubic corner (points **c**, **d** and **e**), where the laser beam passed, was thickly covered by impurity deposition with very rough surface. Therefore formation mechanism of the rough surface is discussed in the following. On the mirror surface both high energy particles from the plasma and impurities come. The former sputter not only the mirror but also impurity atoms deposited on the surface. Some part of the sputtered atoms goes away from the reflector but some of them deposit again on the mirrors. As illustrated in Fig.13, deposited atoms are transported toward the cubic corner by the successive sputtering. At the area near the cubic corner deposited atoms have almost no way to get out from the reflector because each mirror is closely surrounded by the other two mirrors. Namely impurities deposited on the mirror surface pile-up at the narrow cubic corner part by the successive sputtering collision of the energetic particles from the plasma. We can say that impurity deposition is unavoidable for retro-reflectors if both impurities and high energy particles arrive on the mirror surfaces directly. High accumulation of sputtered impurities will occur not only in retro-reflectors but also roof reflectors and the parts where two or more surfaces meet together and form hollow structure, if they face plasma directly.

Fig. 13 Incident direction of impurities and high energy particles at point A, and inter-mirror movement of impurities by sputtering.

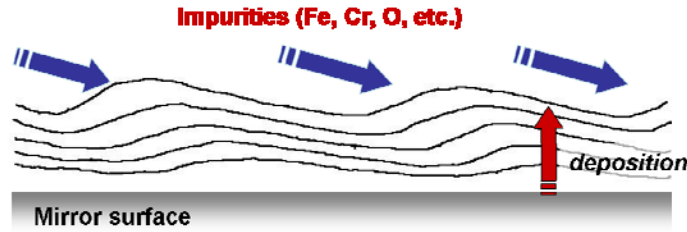
as rough as that of the retro-mirror. Because it is expected that such surface roughening will cause the reduction of the optical reflectivity, understanding of the mechanism developing wave structure is very important. First of all, let us pay attention to the micrograph in Fig.7. Small hills and large projections incline toward the aperture. In the right-hand side of the large projection development of the small hills is slow. These results indicate that average injecting direction of the impurities is not perpendicular to the mirror surface but inclined toward the aperture or the main plasma. If the injecting direction is inclined against the mirror surface as illustrated in Fig.14, wavy surface develop once the surface become uneven and development of the wavy structure is suppressed at the down stream area of the large projections due to the shadow effect of the projections. In case of the retro-reflectors average injection direction of impurities inclined against mirror surfaces, so once the surface become uneven the wave structure develop.

Fig. 14 Development of wavy surface by oblique injection of impurities.

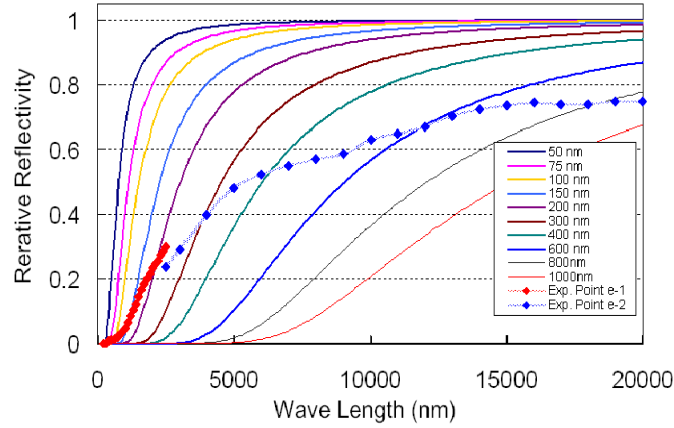
Here,  $R$ ,  $R_0$ ,  $\delta$ ,  $\theta$  and  $\lambda$  are reflectivity, reflectivity of the flat surface, average roughness, reflection angle and wave length, respectively. In Fig. 15, measured reflectivity at the point e is compared with those estimated from equation (1) for several average roughness as a function of the wave length. The very low reflectivity at ultra-violet and visible wave length can be explained roughly by the surface roughness, but large reduction of the measured reflectivity at the longer wave length region can not be explained by the surface roughness alone.

Fig.15 Wave length dependence of relative reflectivity,  $R/R_0$ , estimated from the equation (1) for various average roughness. Relative reflectivity (experimentally measured reflectivity/reflectivity of stainless steel) for the point e is also plotted for comparison.

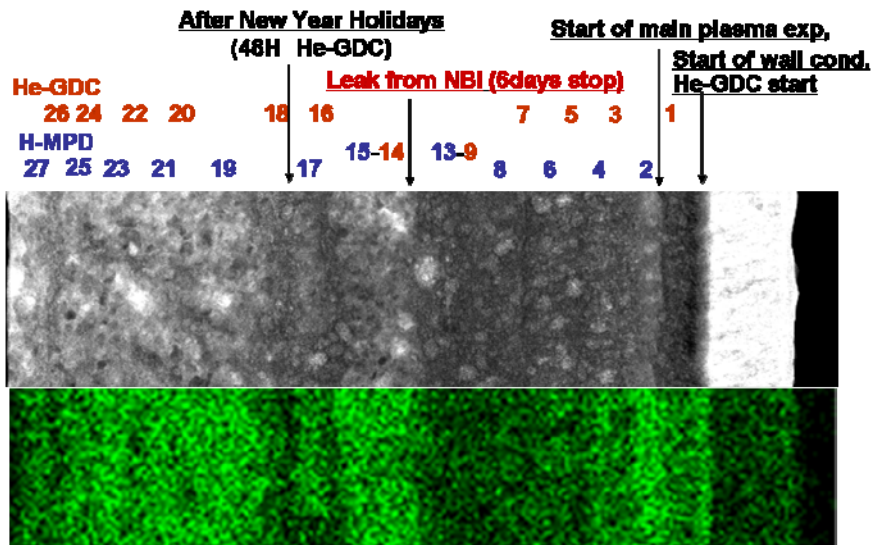
By supposing the identification of the layers, it was tried to assign when each was formed by comparing the discharge history of the experimental cycle. Fig. 16 shows the layer structure of the deposition and the order of main discharge period and He-GDC period. They fit quite well. If the assignment is collect, it is likely that the formation of the blisters, which were the trigger of the wavy surface, occurred after the leakage of cooling water from NBI.

Fig. 16 Comparison of cross sectional microstructure of the deposition and with discharge history
