## §12. Observations of Termination Processes of Long Pulse Discharges in LHD

Shoji, M., Kasahara, H., Mutoh, T.,  
de la Cal, E., Hidalgo, C. (EURATOM-CIEMAT)

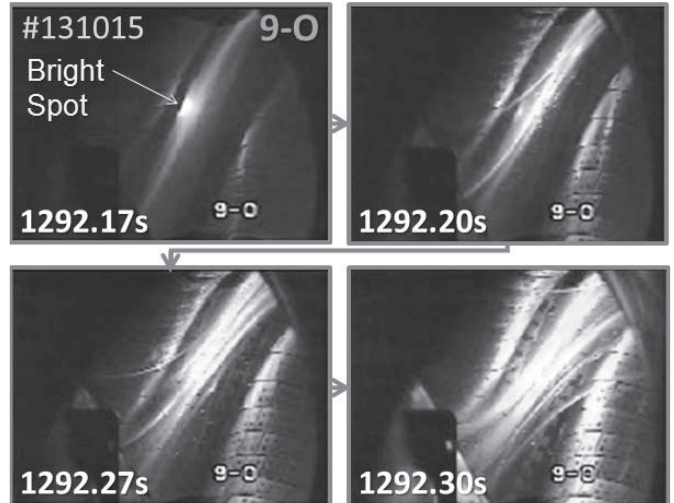
As a typical example of the first plasma termination process, figure 1 shows sequential images of a long pulse discharge observed from an outer port (9-O) just before the plasma termination. In this discharge, a bright spot appeared in a closed divertor region at a position near the equatorial plane in the inboard side of the torus. After that, the bright spot expanded along magnetic field lines in the plasma periphery in the inboard side. A visible spectrometer for monitoring impurity emission in the plasma showed that increase in the intensity of carbon ion emission (CIII) preceded that of iron ion emission (FeXVI). After the experimental campaign, traces of the exfoliation of carbon-rich mixed material layers including brittle iron layers were found on the surface of a dome structure in the closed divertor region. It indicates that large amounts of dusts consisting of the mixed material layers exfoliated from the dome structure penetrated into the main plasma, leading to radiation collapse to terminate the long pulse discharge.

Fig. 1. Sequential images of a long pulse plasma discharge observed from an outer port (9-O), which show dust emission from a position in a closed divertor region near the equatorial plane in the inboard side of the torus.

The above two observations indicate that besides reduction of the deposition of the carbon-rich mixed material layers in the closed divertor regions, control of emission of iron dusts from the surface on the armor tiles by plasma-wall interactions is an essential issue for extending the duration time of the long pulse discharges. In addition to this, understanding on the physical mechanisms of the formation of the arc traces and investigation of the physical processes that initiates the arcs are important issue to realize steady state plasma discharge operation in LHD.

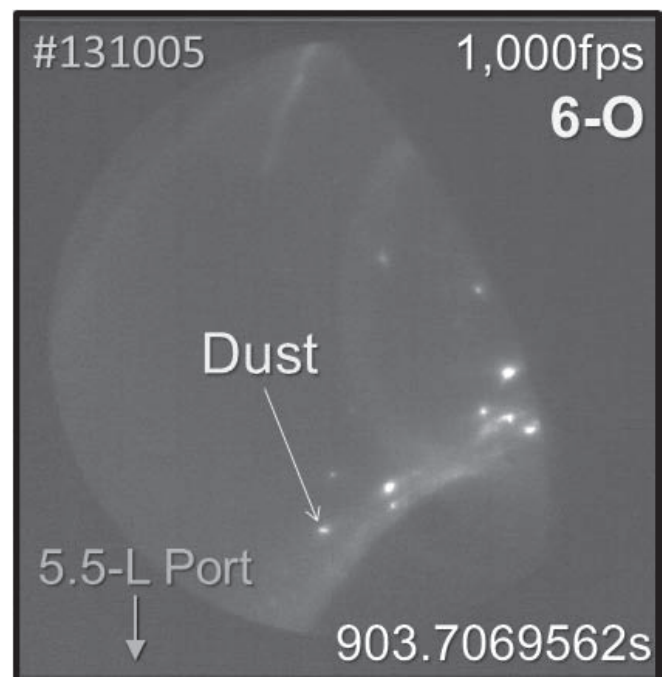
As a typical example of the second plasma termination process, figure 2 presents a snapshot of a long pulse discharge taken with a tangentially viewing fast framing camera installed in an outer port (6-O) just before the plasma termination. It shows that large amounts of small incandescent dusts released in the plasma. The dusts appear to be from positions around a lower port (5.5-L). The visible spectrometer showed that increase in the intensity of the iron ion emission preceded that of carbon ion emission. After the experimental campaign, a number of arc traces on the surface of armor tiles for protecting a side vacuum wall of a helical coil can were found on the site near the lower port. It strongly suggests that the large amounts of iron grains were sputtered from the surface of the stainless steel armor tiles penetrated into the main plasma, leading to termination of the long pulse discharge.

Fig. 2. A snapshot of a long pulse plasma discharge showing a number of incandescent dust release in the plasma, which was taken just before the plasma termination from an outer port (6-O).
