§7. Change in Surface Morphology of Retroreflector Installed in LHD

Akiyama, T., Masuzaki, S., Tokitani, M., Yoshida, N., Tokunaga, T. (Kyushu Univ.)

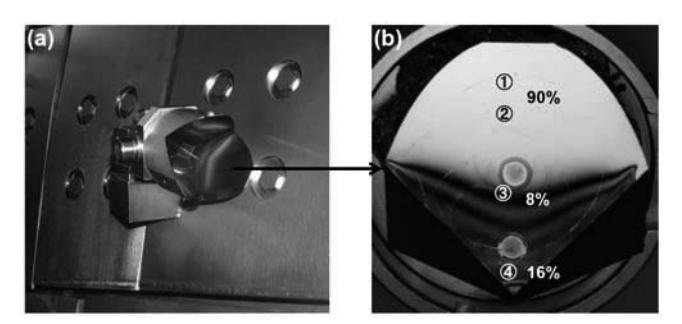
Figure 1 (a) shows a retroreflector made of stainless steel installed on the LHD vacuum vessel for a dispersion interferometer. The retroreflector consists of three mirror pieces and one of them after exposure to one experiment campaign is shown in Fig. 1 (b). Impurities deposited especially in the central region due to the accumulation effect [1]. While the reflectivity of visible laser light (633 nm) at the edge region is almost the same as that before plasma exposure, that in the central region decreases down to about 10%.

The interference stripes indicate change in the thickness of the depositon layer. The difference in the thickness between the neighboring stripes with the same color is $\lambda/(2n)$, where λ and n are the wavelength and the refractivity. Supposing that the thickness is monotonically increases, the thickness of the deposition layer at the central region is estimated to be around 600 nm from the four black stripes.

Fig. 1: (a) A retroreflector installed in LHD. (b) One of mirror pieces and the reflectivities at the visible laser light (633 nm). Circular marks near position ③ and ④ was made by GD-OES analyses (not discussed in this report).

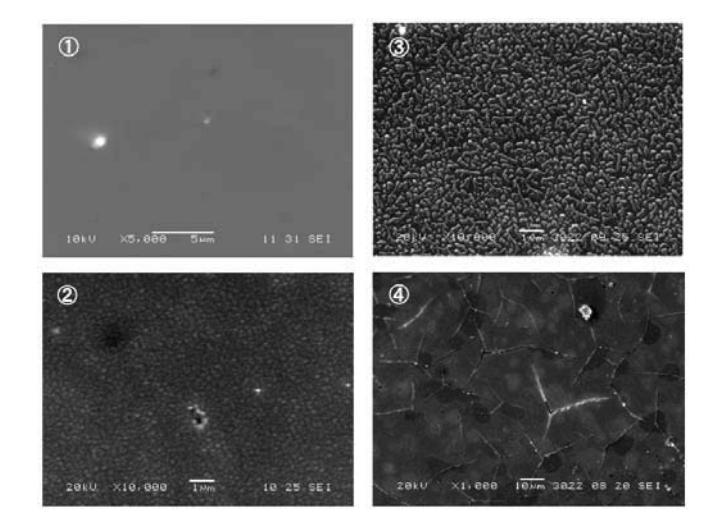
SEM images of the mirror surface are shown in Fig. 2. The surface flatness is maintained at the position ① where the reflectivity does not change. There is almost no impurity deposition there; the elemental analysis by EDS indicates only Fe and Cr, which originate from the bulk stainless steel. The sputtering by glow discharges and charge exchange particles does not cause surface roughness on LHD. Although the original reflectivity is maintained, the impurity deposition with fine surface roughness or nonuniformity in the layer appears at the position 2. The surface pattern becomes significant at the position 3 where the interference is visible. As shown in Fig. 3, the EDS analysis indicates the deposition layer consists of carbon. At the central region, branched swollenness are formed on the surface and some of them break. It is speculated that the gas trapped in the grain boundary of the stainless steel is released and then the carbon deposition layer becomes swollen. This should be a source of dusts, in addition to the reflectivity degradation.

Fig. 2: SEM images at the position $\bigcirc - \bigcirc$ in Fig. 1(b).

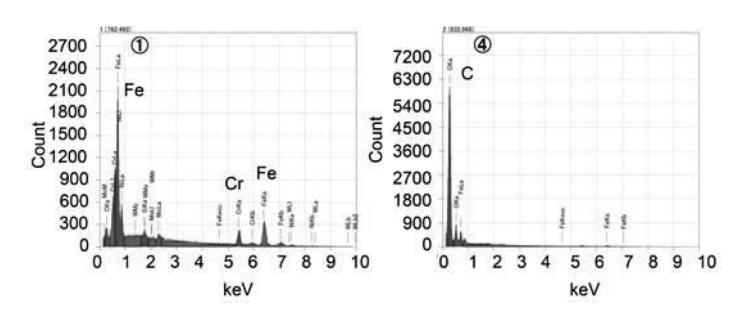
Fig. 3: EDS spectra at position ① and ④ in Fig. 1
