## **SAFETY TRIP REPORT**

# **ON US-JAPAN EXCHANGE PROGRAM**

## Report on the 13<sup>th</sup> Meeting of the Joint Working Group of the U.S-Japan Coordinating Committee of Fusion Energy on Safety in Inter-Institutional Collaborations (U.S.-Japan Safety Monitoring Program) February 22-25, 2010

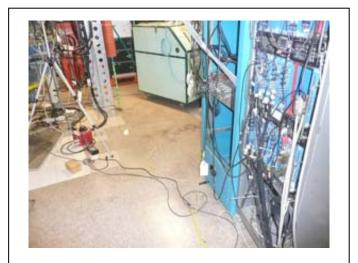
Fig. 14. Cablings on the floor.

Cablings on the floor should be limited the temporary usage (Fig. 14). (T.S. & K.N.) If it needs

to keep them permanently, it must be protected with suitable coverings.

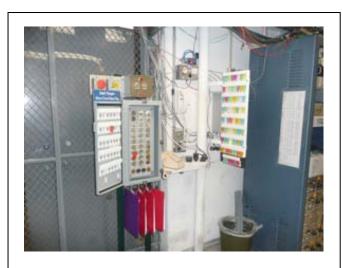
Fig. 18. Keys for door interlock.

Door access is controlled by using the various keys and it is linked to the interlock system (Fig. 18). It is simple and effective. (A.S., T.S. & K.N.)

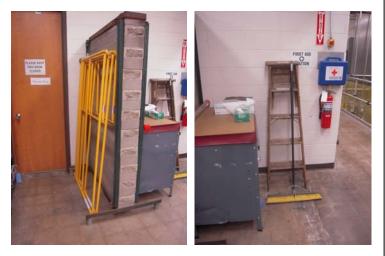
Fig. 33. A knockdown fence, a stepladder and a bloom are stood against a wall.

knockdown fence, stepladder and a broom are stood against a wall (Fig. 33). Since there are many earthquakes in Japan, most equipment must be fastened to prevent from falling down. However, the cause of falling down of equipment is not only by earthquake. For example, accidental hard hit of carrying cart may cause falling down. Such falling down may give the

secondary damage to the other equipment or a co-worker. From the view point of preventing falling down, stacking goods at high position needs to special attention (Fig. 34). (A.S. & K.N.)

Although Japanese participants can understand that such difference of safety standards between Japan and the east coast in United States is based on a geographical environment, we recommend to the US safety

staff consider the things mentioned above. (A.S. & K.N.)

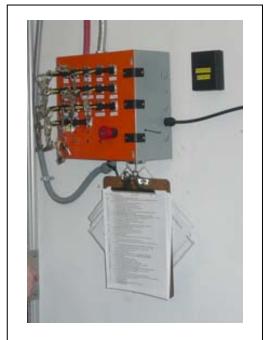
Fig. 36. Keys for door interlock.

Door access is controlled by using the keys and it is linked to the interlock system (Fig. 36). It is simple and effective.

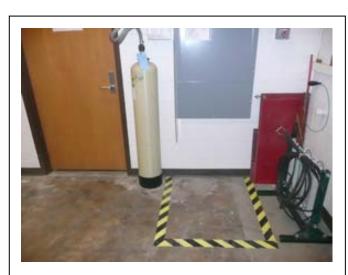
Fig. 37. Partitioning off the front area of the power supply board.

Partitioning off the front area of the power supply board by taping is effective to keep area clear. If the tape was made by the fluorescent material, it can be seen during a power failure (Fig. 37). (T.S. & K.N.)

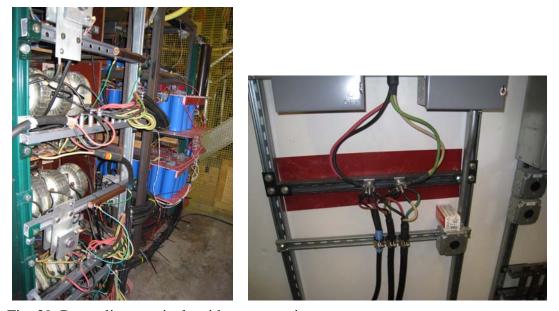
Fig. 39. Power line terminals without protecting cover.

The current terminals of power line should be coved with protecting cover to prevent an accident of electric shock (Fig. 39). (K.N.)
