# Reflectivity Reduction of Retro-Reflector Installed in LHD due to Plasma Surface Interaction

**Abstract:** Optical reflectivity of the retro-reflector installed in LHD as the first mirror was reduced seriously by plasma wall interaction. In order to understand the mechanism of the reflectivity reduction, optical and material properties of the mirror surfaces have been examined extensively. It was found that the deposited impurity layers caused the serious reduction of the reflectivity. Formation of iron oxide, bulges structure and He bubbles are the major factors for the reflectivity reduction in the wide wave length range.

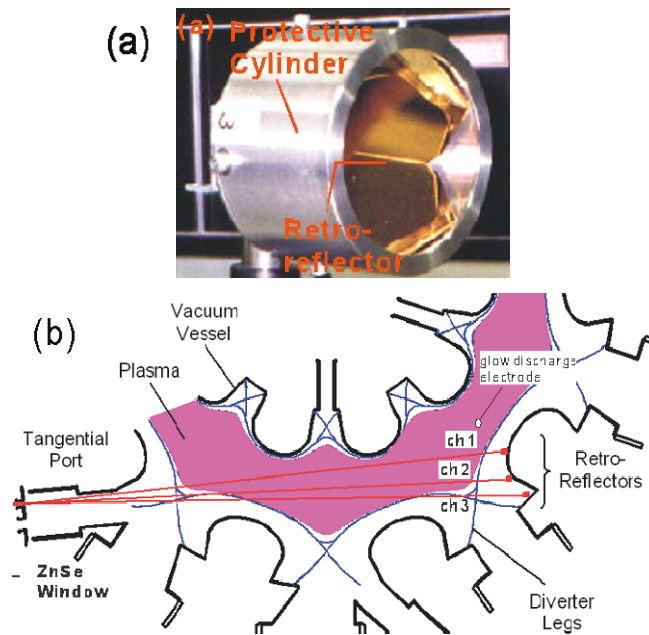
protected by a cylinder made of 303SS. Each mirror made of 316SS was plated with gold of about 300nm-thick to get high optical reflectivity [9]. The positions of the retro-reflectors in the LHD are illustrated in Fig. 1(b). The main plasma can be widely viewed from the position. In the present work, the retro-reflector of the Ch 1, which is closest to the plasma, was examined mainly. The reflectors were exposed not only to the main plasma discharges of hydrogen and helium but also helium plasma of about 200eV for glow discharge cleaning (GDC) through the whole experimental cycle.

Fig. 1 (a) Retro-reflectors installed in LHD. Gold-plated flat reflectors are seen. (b) Positions of the retro-reflectors and laser beams are shown.
