Damage evolution and particle retention in metals bombarded by neutral helium particles at the first wall positions in LHD

Keywords: Large Helical Device (LHD), Helium, Charge-exchanged neutrals, Microscopic damage, Transmission Electron Microscopy (TEM)

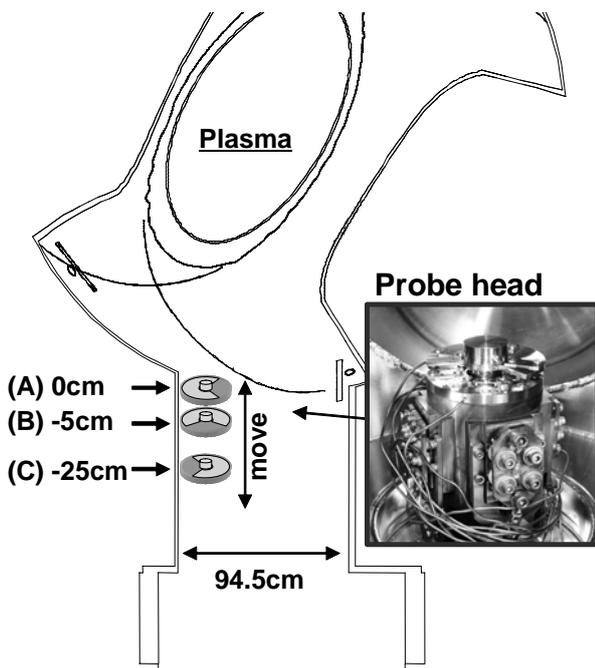
Fig. 1 Schematic view of the experimental set up on movable material probe system in LHD.

Specimens of Mo and stainless steels mounted on the probe head were placed at the first wall equivalent position by using movable material probe system which installed in LHD, and then, exposed to the NBI + ICRF heated helium discharges. This material probe system makes possible to select desirable plasma discharges and irradiation position by using shutter and vertical movement mechanism. Fig. 1 shows a schematic view of the experimental set up in this study.

Total discharge time at each irradiation position which is identified by the distance measured from the first wall equivalent position and typical plasma parameters summarized in Table 1. For convenience these positions are denoted as (A), (B) and (C). (B) and (C) are the positions in 4.5L port as illustrated in Fig. 1. The temperature of the probe head during exposure was

Table 1 Total discharge time at each irradiation distance from the first wall position as illustrated in Fig. 1 and typical plasma parameters. 0 cm corresponds to the first wall equivalent position. (Direction of -25 cm is farthest from plasma)

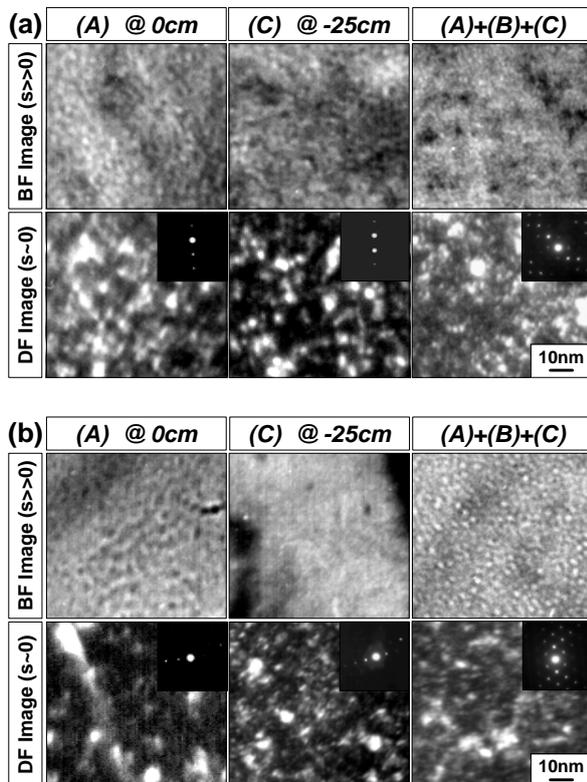
Fig. 2 TEM images of (a)-Mo and (b)-stainless steel specimens after exposed to ICRF heated helium discharges, BF images at large deviation parameter s (upper series). White dot contrast in DF images shows dislocation loops (lower series).

Fig. 2 shows TEM images of (a)-Mo and (b)-stainless steel exposed to the NBI+ICRF heated helium discharges for the case of (A), (C) and (A)+(B)+(C). (A)+(B)+(C) means the specimen exposed at all positions. The upper series of micrographs of (a) and (b) are bright field images with large deviation parameter s . White dot images are helium bubbles. The lower series of (a) and (b) are dark field images with small deviation parameter s , which fits for observation of defects with strong lattice distortion such as dislocation loops and helium platelets. Defects with a strong white image, mainly dislocation loops. Although total irradiation time was only 349 s~1138 s, considerably large amounts of helium bubbles of about 1 to 2 nm and dislocation loops of about ~20 nm were formed in both specimen and all cases. Evolution of the microscopic damage was already saturated at the case of both (A) and (C). Thus, since the creation rate of defects in all specimens was very high, unfortunately, the difference of the damage rate could not identify as a function of irradiation time and position. This means that the damage is caused by CX-helium atoms which are not affected by magnetic field, and their energy and flux are sufficiently higher to create these defects. In general, radiation induced secondary defects are formed as aggregates of point defects produced by knock-on processes. Since the threshold energies of helium for displacement damage in Mo and stainless steel are about

0.23 keV and 0.10 keV, respectively. The size and density of defects between (A) and (C) were very similar in both specimens. It indicates that the flux of CX-helium atom does not decrease much even in the port.

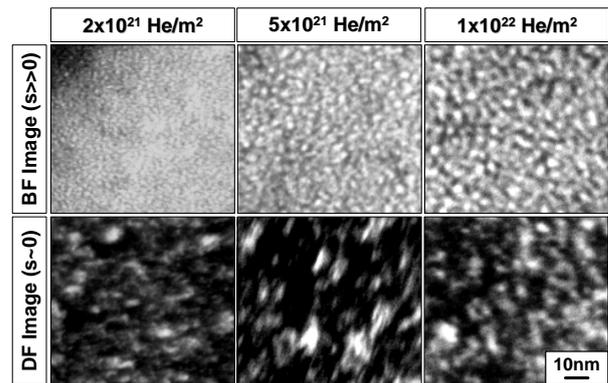
Fig.3 Microstructural evolution in stainless steel during helium ion irradiation ($\sim 1 \times 10^{22}$ He/m²) at room temperature with energies of 2 keV. BF images at large deviation parameter s (upper series). White dot contrast in DF images shows dislocation loops (lower series).

It was tried to estimate the flux and energy of CX-helium atoms to the first walls by comparing with systematic in-situ helium ion irradiation experiments [13]. The microstructural evolution of stainless steel at room temperature under irradiation with 2 keV-He⁺ ions is shown in Fig. 3. Some of the images are re-produced data from Ref. [13]. The upper series of micrographs are bright field images with large deviation parameter s . The lower series are dark field images with small deviation parameter s . When Fig. 3 compared with Fig. 2-(b), size and density of helium bubbles and dislocation loops of the all cases of Fig. 2-(b) is corresponds to $2\sim 5 \times 10^{21}$ He/m². Therefore, the estimated flux and incidence energy is $2 \times 10^{18} \sim 1 \times 10^{19}$ He/m²s and about 1~2 keV, respectively. As mentioned above, majority of such incidence helium particles are energetic neutrals. This estimation is relatively rough. However, it is important

the case of only NBI heated helium discharges, very similar damages were confirmed after exposed to only ~ 100 s discharges in Mo and stainless steels specimens (not shown here). In the case of 2 keV-He⁺, it was reported that at a dose level of lower than $\sim 10^{20}$ He/m²s, injected helium atoms are trapped by vacancy-helium complex and helium bubbles and finally filled with them. Above this dose level, additional trapping of helium atoms by helium bubbles become difficult [13].

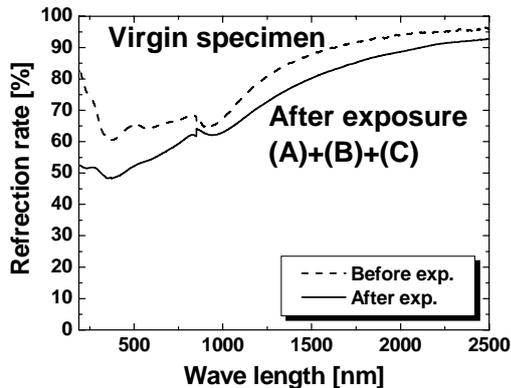
Fig.4 Optical reflectivity of Mo specimen after exposed to ICRF heated helium discharges. Solid line shows (A)+(B)+(C) in table 1. Dashed line shows virgin specimen.

Fig. 4 shows the optical reflectivity of Mo specimen after exposed to NBI+ICRF heated helium discharges. This spectrum is from the specimen exposed to all position, (A)+(B)+(C) in table 1.

Reflectivity of virgin specimen was also plotted. It is clear that reduction of reflectivity has already occurred at the exposure time of only 1138 s. In particular, reduction of reflectivity about 500 nm or less is remarkable. Referring to our previous study [12], it is considered that reduction of optical reflectivity is due to the multiple scattering of light by the dense helium bubbles in the sub-surface region. In comparison with hydrogen irradiation, remarkable degradation of the optical reflectivity induced by hydrogen ions irradiation with similar energy occurs at the fluence above 10^{25} ions/m² [9]. We should note that effect of helium bombardment is three orders of magnitude higher than that of hydrogen bombardment. This result is important for the design and
