§12. Deposition Layer Study Using Material Probes on the First Wall in LHD

Bawankar, P.S. (Grad. Univ. Advanced Studies), Masuzaki, S., Tokitani, M.

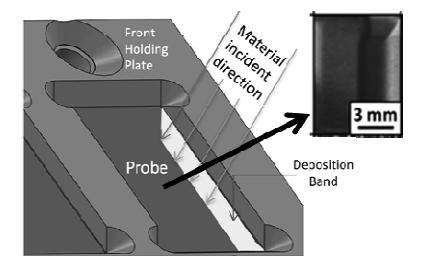
Fig.1 The deposition pattern has been formed by incident deposited materials across the probe holder in a particular direction.

After exposure visible deposition (band) pattern has been formed on almost all the specimens (Fig 1). However the SEM images for all specimens shown similar smooth surface conditions except few probes which were near to GDC anode^{1,2)}. All specimens have light brown color bands on their right side. The widths of the bands are around 1.5 mm to 2.5 mm. Some specimens have left side bands accompanied with bottom horizontal bands.

EDS analysis showed that main deposited material was C. Other deposits were B, Ti and components of SUS316. As can be seen right side of visible bands has angle at the top side. It seems that materials deposition on the specimens has followed a particular direction of incidence. As shown in Fig. 1 the holding plate has the conic section at top and bottom corner of its rectangular opening. Making use this typical geometry it became possible to calculate two angles of line of incident direction. The incident deposited materials have projected top angular section of the holder plate on the specimen plane resulting in the top angular section of deposition band.

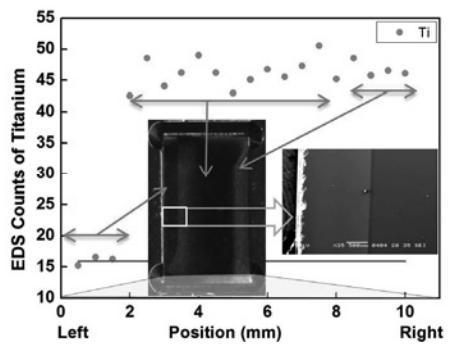
Fig.2 Horizontal EDS scan of Ti. Horizontal pink line shows the EDS counts of Ti on fresh Si. On the graph also shown SEM scan on left band of the specimen.

The incident line of deposited material has been traced in CAD. The incident line calculated for right side band shown to be pointing to the specific divertor plates. It suggests that eroded materials from divertor plates directly reached to the specimen. It is not clear, however when the materials came from the divertor plates whether during GDC or main plasma operation. Similarly left side band formed due to incoming of Ti. EDS scan of Ti shows that deposition is much lower than that of at the middle and at right band of the specimen (Fig 2).
